# **Standing Stone Creek Water Quality Pre-Assessment**

**Margo Wilson  
Kaleigh Felisberto  
and  
Amy Slicker  
2000/2001**

# Standing Stone Creek Assessment

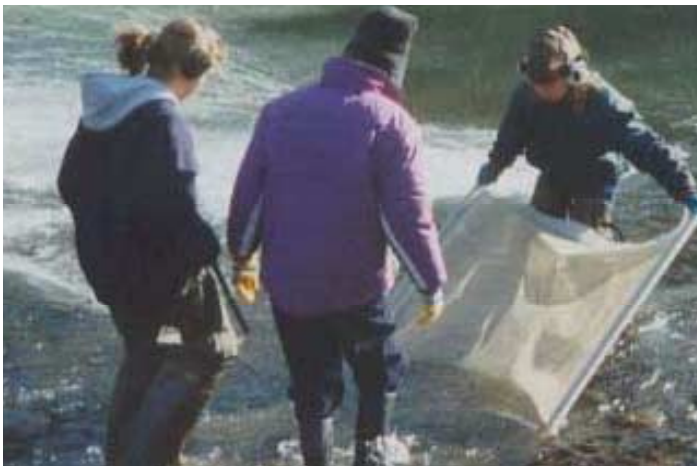
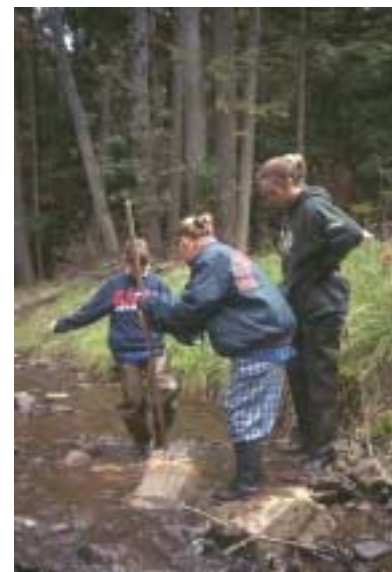
HAMS students collect macroinvertebrates using a seine net, left, and D-Net, right.

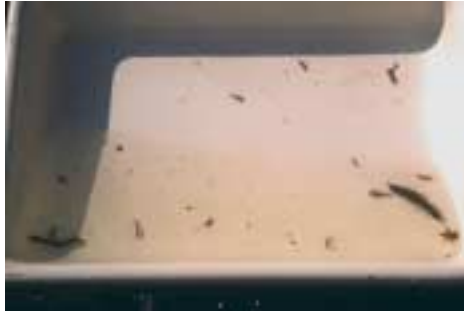
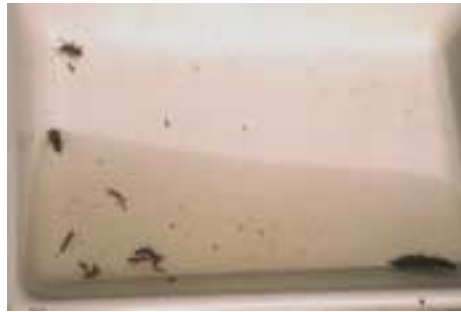
Collected specimens are placed in white pans for identification

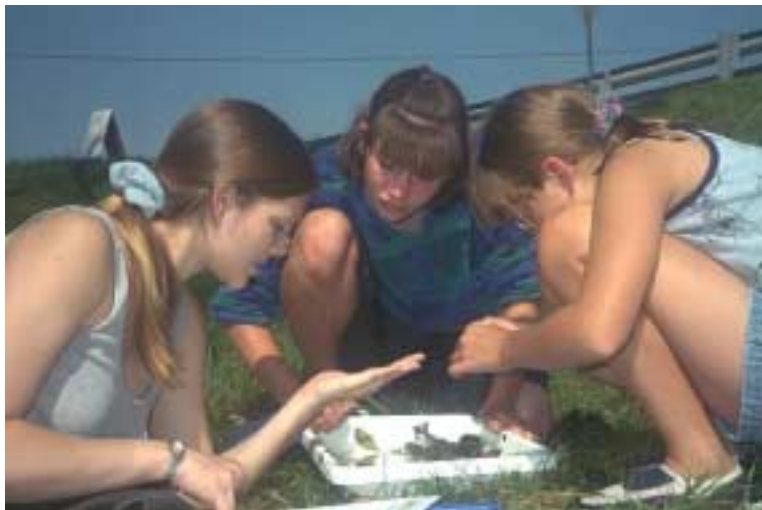
Sorting and proper identification of aquatic organisms must occur to obtain a valid assessment of the water quality.

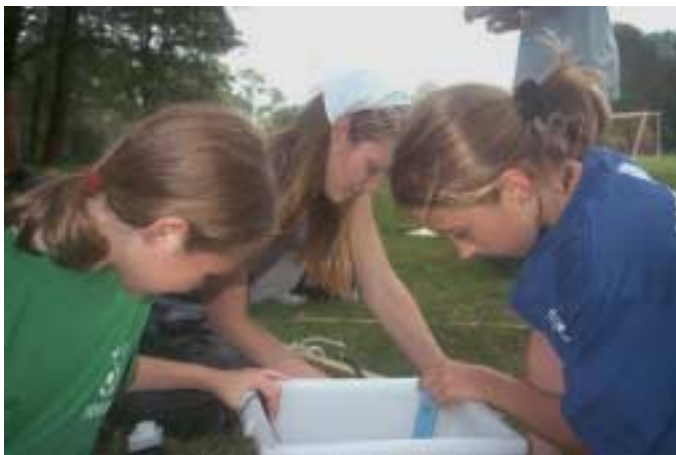
To find the pH, we used a LaMotte pH Meter and Hach pocket pH pen. We set or calibrated the pH tester by putting it in a pH buffer solution of 7.0. A pH of 7.0 is neutral. This means that the liquid is not an acid or base (acidic or alkaline). Once the pH meter reading was set at 7.0, the probe was placed into the water sample. Then, we waited until the meter showed a constant number. This number is the pH of the water. A number less than 7.0 would show that the water is an acid. A number greater than 7.0 indicates that the water is alkaline.

Student researchers obtain the pH of the water by conducting several repetitions using a pH meter and pH pen. Juniata College, student intern, Heather Galbraith records the information.

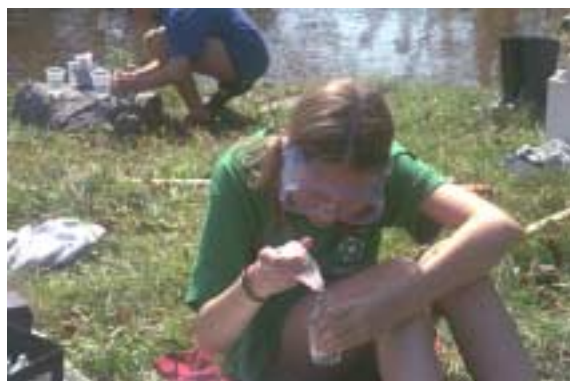
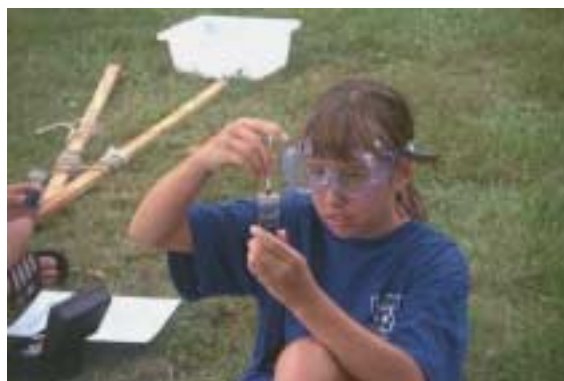
We used a LaMotte Dissolved Oxygen Kit and the Otterbine Sentry III Oxygen/Temperature Monitor to get the dissolved oxygen (amount of gaseous oxygen) level of the water.

Two Huntingdon Area Middle School students conduct separate dissolved oxygen tests of Standing Stone Creek. Conducting repetitions of the test provides a more accurate indication of the amount of gaseous oxygen in the water.

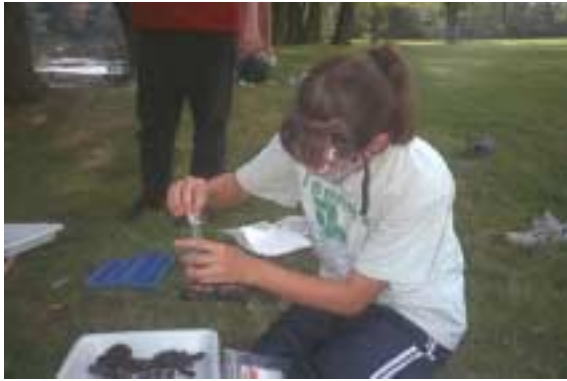
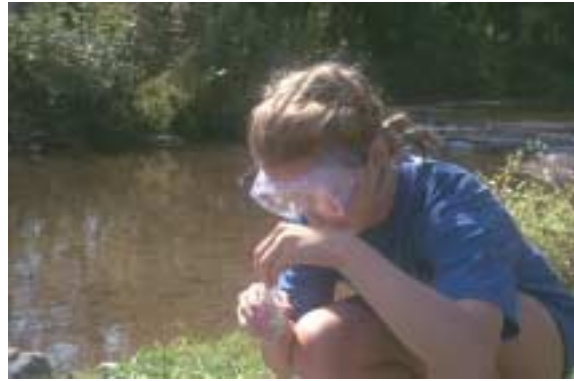
To discover the total hardness and alkalinity levels, we used two chemical water testing kits. For hardness, we used a LaMotte Hardness Kit, and for alkalinity, a Hach Alkalinity Kit. Both these tests require following instructions for mixing different chemicals, giving the test result in parts per million (ppm).

Pictures above, left, a student conducts an alkalinity test, on the right, total hardness, as part of a pre-assessment of the water quality of Standing Stone Creek.

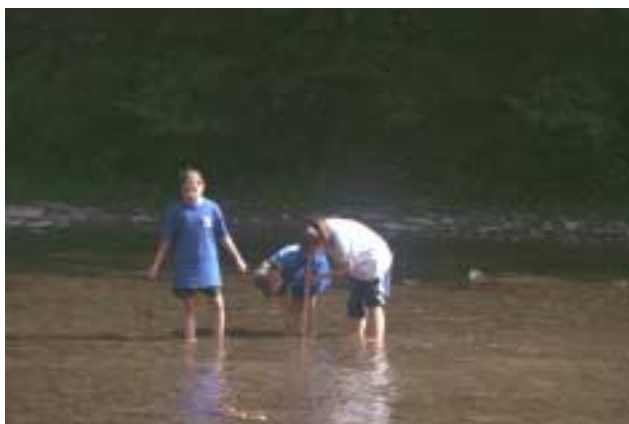
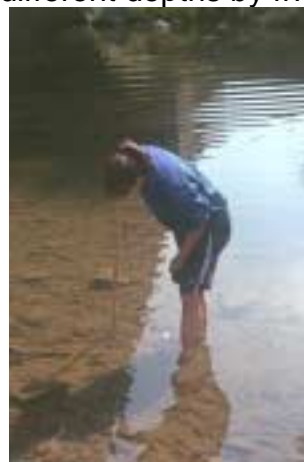
We got the average depth of the stream by taking five measurements at different locations using a meter stick and dividing the total of the five different depths by five.

A cadre of students works together to obtain the average depth of the water.

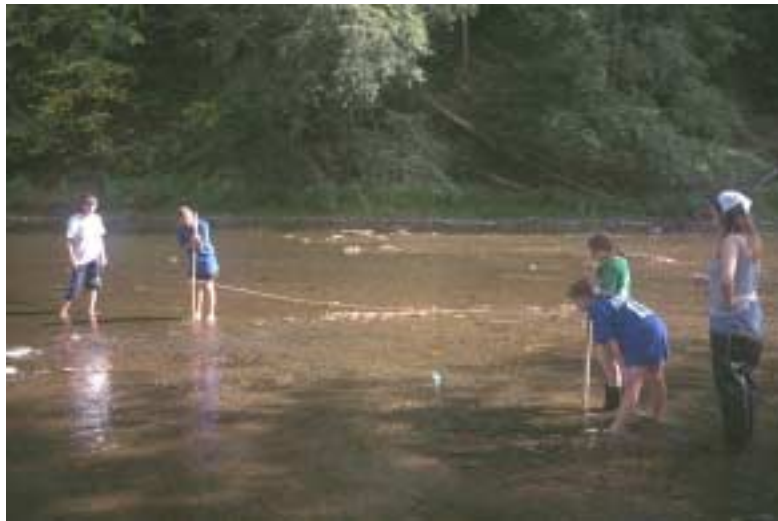
would be going the same speed of the water when it reached the stick. When the ball reached the first stick, someone would yell, "Start" and we would start the stopwatch. When the walnut reached the downstream stick, someone would yell, "Stop," so that we would stop the timing. We did this procedure five times, recording the time the ball needed to travel the five meters each time.

Students learn water speed by timing the rate a ball takes to flow five meters.

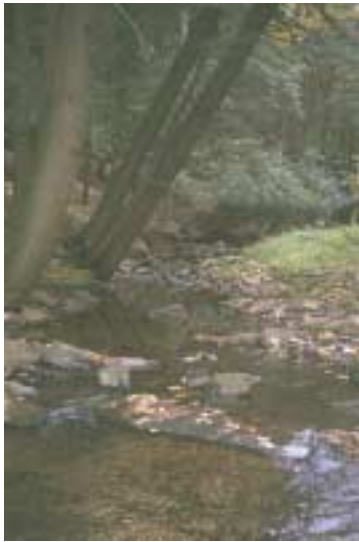
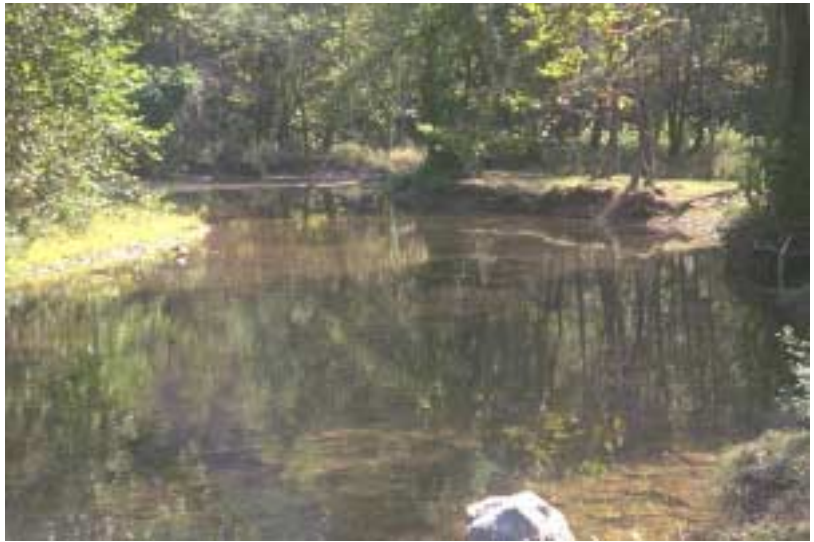
The pre-assessment included examining the stream from its headwater to mouth. The picture on the left is in the forest area Standing Stone Creek's headwater. The picture on the right is near the confluence with the Juniata River.

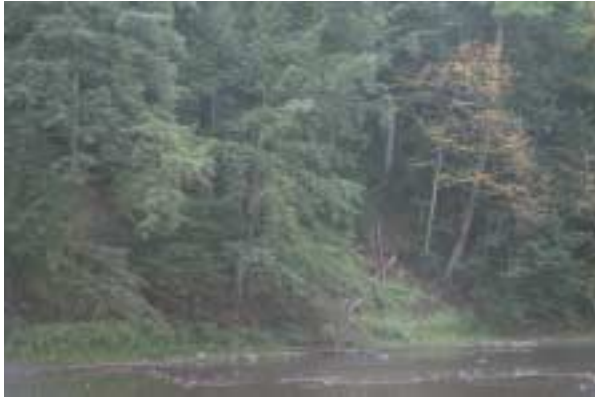
streambank related problems. The right side, adjacent to Standing Stone Creek Ridge, was more stable.

Riparian areas along Stone Creek Ridge were more established.

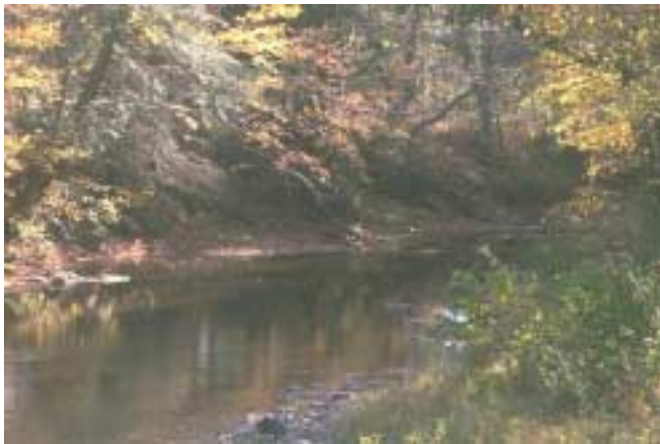
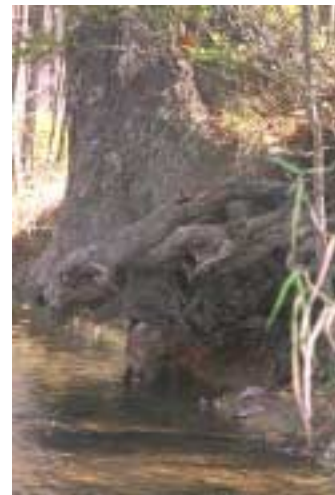
(Left) and (Right) Moderately stable: infrequent, small areas of erosion mostly healed over.

Eroded vertical banks as illustrated in the two pictures taken near Black's Bridge, about 4 miles north of Huntingdon, were discovered in several areas of the stream.

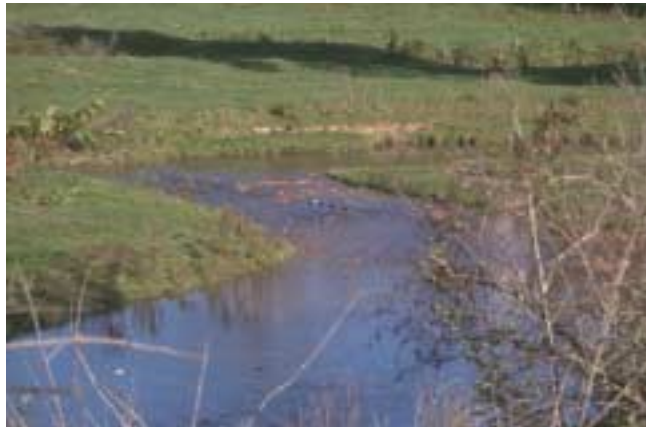
(right) Width of riparian zone 35-40 feet; no evidence of human activities, e.g., parking lots, roadbeds, clearcuts, mowed areas, or crops) within the riparian zone. Note: Agricultural activity near Cunningham Bridge lowered average.

Bank vegetative protection in agricultural areas throughout the watershed is limited as seen in the adjacent picture taken south of Cunningham Bridge about 15 miles north of Huntingdon.
